## Tailored renovation solution

- ✓ 890 metres of VipLiner modules DN 375, with 23 drains made to measure

The Vierimaantie road, located close to the town centre of Ylivieska, Finland has a concrete sewer line constructed in the 1960s and 1970s. A decision was taken to renovate this sewer using a tailored solution, and the product developed for this purpose is now also available to other customers.

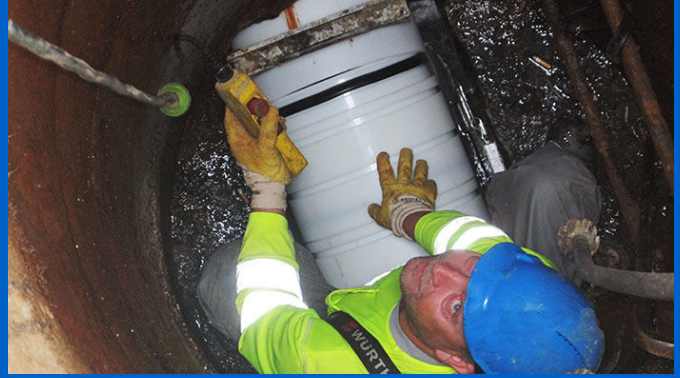
Uponor Infra's tailored VipLiner module provided a solution to enable the renovation of a concrete sewer line located close to the centre of Ylivieska. In addition to a new diameter size, modules were manufactured with a shorter length than standard modules, enabling the tight curves in the line to be implemented without difficulty.

VipLiner short section relining is a quick and easy way to improve the condition of old, leaking concrete sewers. A new pipe consisting of interlocking modules of 50 centimetres in length is inserted into the old pipe. If necessary, the area between the old and new pipes can be filled with autoclave foam concrete. As the renovation is completed using modules from one drain to the next, there is almost no disruption to traffic or the local environment. There is also no need for wastewater to be diverted as the pipeline can be in operation throughout the renovation. A new diameter size was developed for the VipLiner module at Uponor Infra's factory in Vaasa, Finland.
